Fire Tests of Steel Columns Protected With Siliceous Aggregate Concrete

United States Department of Commerce
National Bureau of Standards
Building Materials and Structures Report 124

Nolan D. Mitchell

Issued May 25, 1951

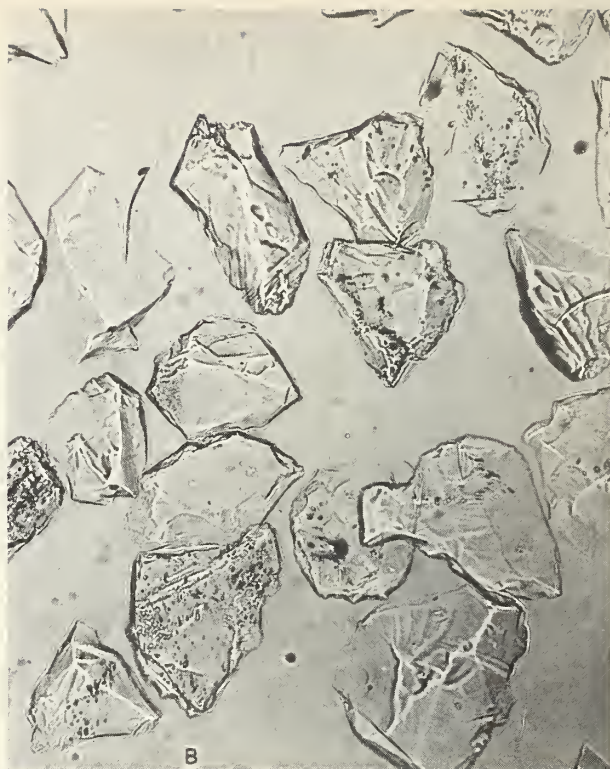
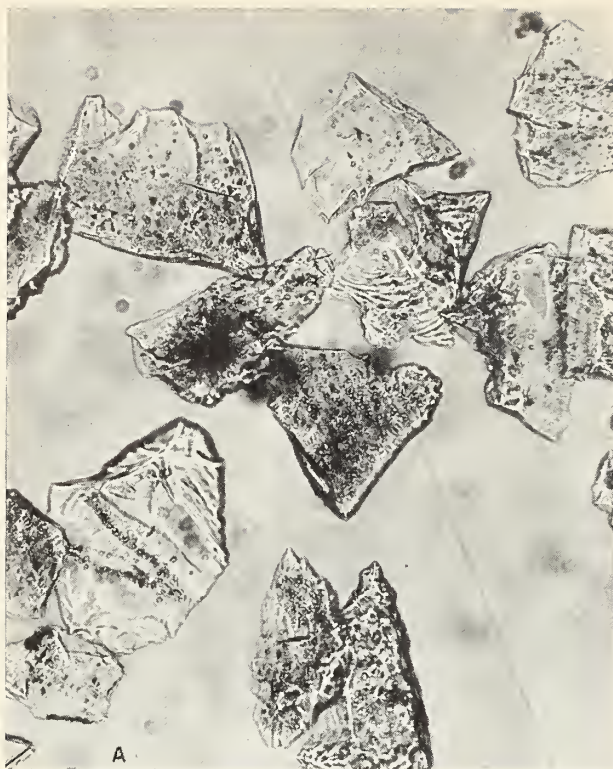
FIGURE 3. Photomicrographs of crushed quartz aggregates showing inclusions or voids (X96): A, milky; B, clear.

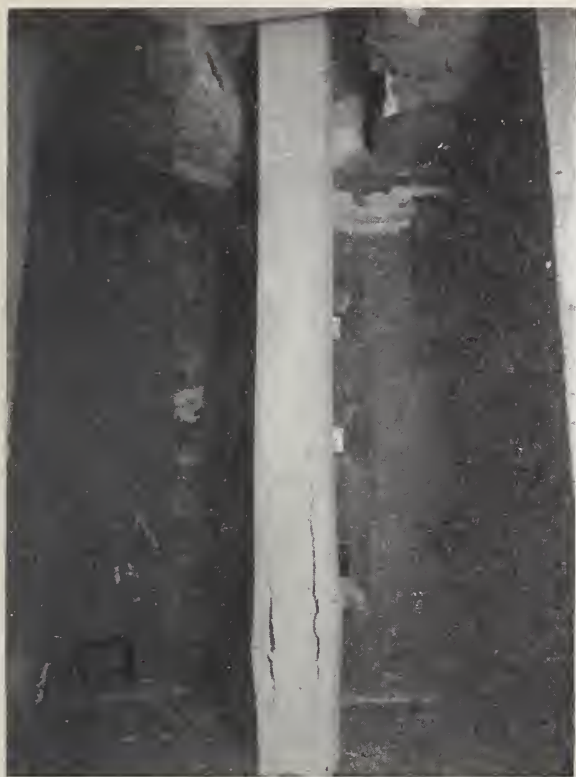
The condition of the gravel aggregate concrete column protections after the fire test are shown in figures 1 and 7. Figure 8 shows the two columns after removal of the concrete encasement.

FIGURE 7. Condition of gravel aggregate concrete column protection after 3½-hr fire exposure.

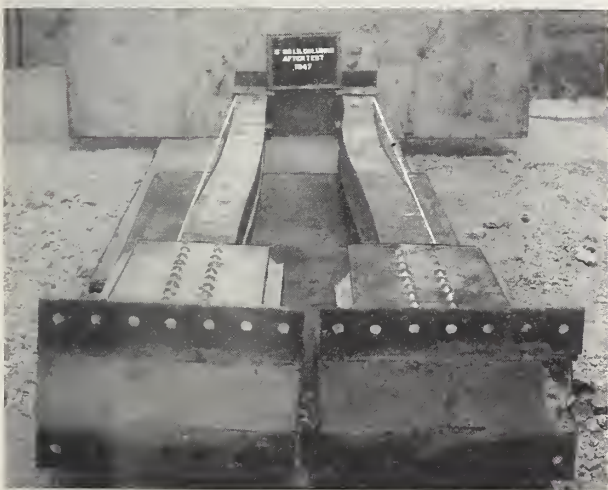
The failure of both columns involved deformation throughout the fire-exposed lengths. The lateral deformation of column 1 was somewhat greater than that of column 2 and was centered somewhat lower in the shaft. Although the lateral deflections were unequal, the total shortening of both columns, as determined by measurements before and after the tests, was the same, 0.4 in.

FIGURE 8. Condition of columns after tests 1 and 2—Concrete removed.

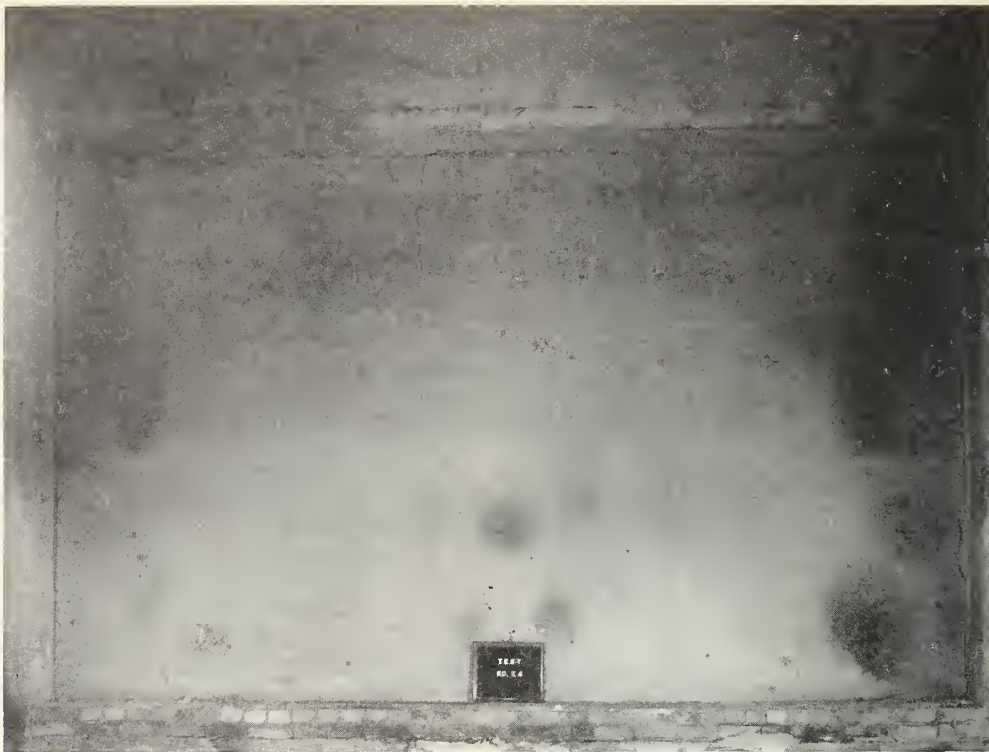
The Potomac River gravel concrete of three monolithic walls did not spall or develop serious cracks throughout the fire- and load-test periods. Two reinforced concrete walls 4 and 6 in. thick were exposed for 1 hr 27 min and 4 hr, respectively. Figure 9 shows the fire-exposed face of an 8-in.

unreinforced wall after 5½ hr test. These walls suffered only minor cracking and in no case was there evidence of spalling.

FIGURE 9. Fire-exposed face of an 8-in. unreinforced wall of Potomac River gravel concrete after 5½-hr test.

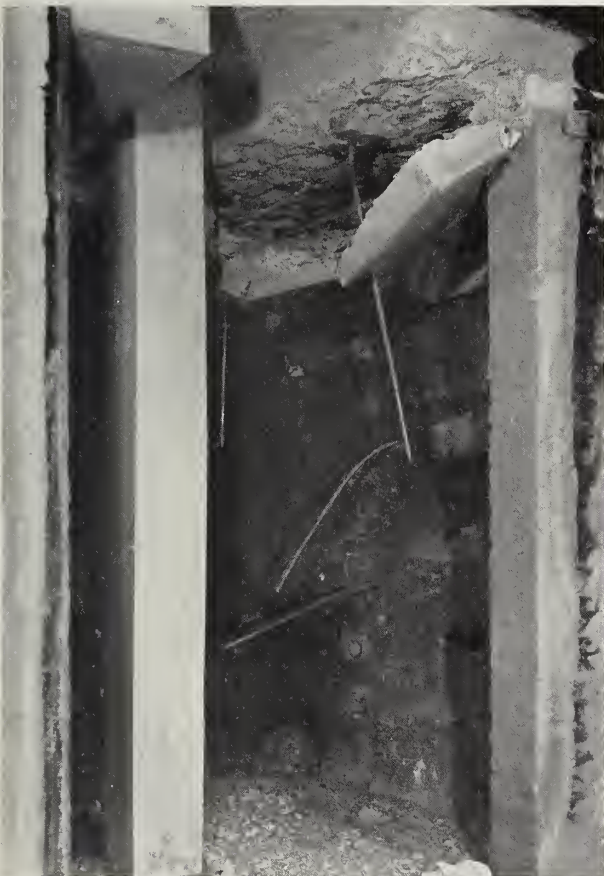
Both columns suffered lateral deformations in their fire-exposed portions. The concrete with milky quartz aggregate of column 3 showed only minor cracking at the end of the test, as is seen in figure 12. Failure to cease application of the load at the end of the test when the contraction had reached the predetermined value of ⅝ in. caused severe bending of the shaft of column 4. The clear quartz aggregate concrete showed little cracking and no evidence of spalling prior to the excessive deformation.

FIGURE 12. *Column protected with milky quartz aggregate concrete after 3-hr 10-min fire exposure—Test 3.*

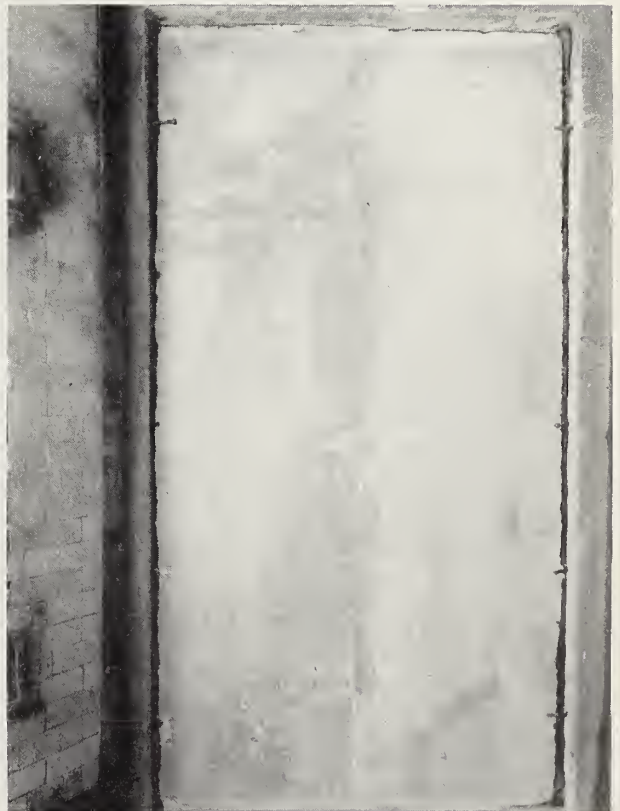
The quartz aggregate concrete of a 4- by 8-ft wall slab 4 in. thick showed only a fine crack in the line of a pouring joint after a fire exposure of 1½ hr. The slab was poured in quarters from the same milky and clear quartz concrete batches used for columns 3 and 4, the sections with like aggregate being diagonally opposite. Figure 13 shows the fire-exposed face of the wall after removal from the furnace.

FIGURE 13. *Fire-exposed face of a crushed quartz concrete wall slab after 1½-hr test.*

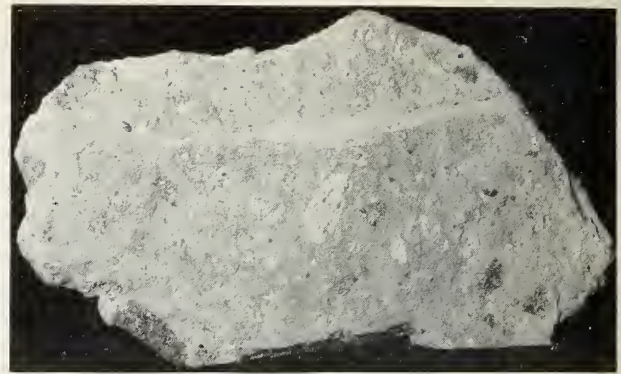
The resistance of a concrete to high temperatures is probably influenced by its density. The spalling caused by the explosion resulting from superheated water in a dense concrete was previously mentioned in connection with the failure of a floor slab made with siliceous aggregate concrete. Further evidence of this effect can be seen in figure 12, which shows failure of the concrete top of the furnace after the first fire-endurance test to which the concrete was subjected. The failure occurred with explosive force 34 min after a 3-hr 10-min fire exposure, at which time the furnace still retained considerable heat. Examination of the debris showed the concrete, made with carefully graded firebrick aggregate, to be extremely compact. The structure of the spalled material can be seen in the photograph of the sample in figure 14.

FIGURE 14. *Sample of firebrick aggregate concrete spalled from top of furnace.*
